SHAKER HEIGHTS

FACILITY ASSESSMENT

Thornton Park

December 15, 2021

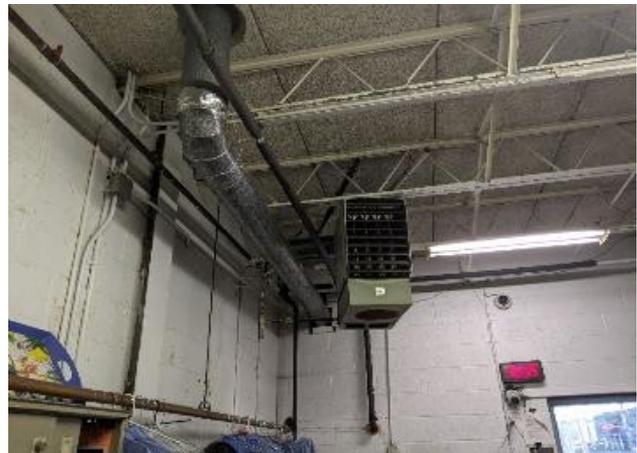
- There is a Roberts Gordon infrared heater, approximately 20-25 years old, around the perimeter of the Ice Arena. Life expectancy is another 10 years.
- The Battery Charging Room has a gas-fired unit heater adjacent to where propane is used periodically for the Zamboni.
- The Pool Building is heated utilizing natural gas unit heaters and ducted unit heaters. Generally this system is in fair condition.

Unit Heater in Battery Charging Room

Item	Cost	Unit	Whole Building	Sum	Comments
Relocate Unit Heater	\$7,500.00	LUMP SUM	1.00	\$7,500.00	
Ice Arena Sum:				\$7,500.00

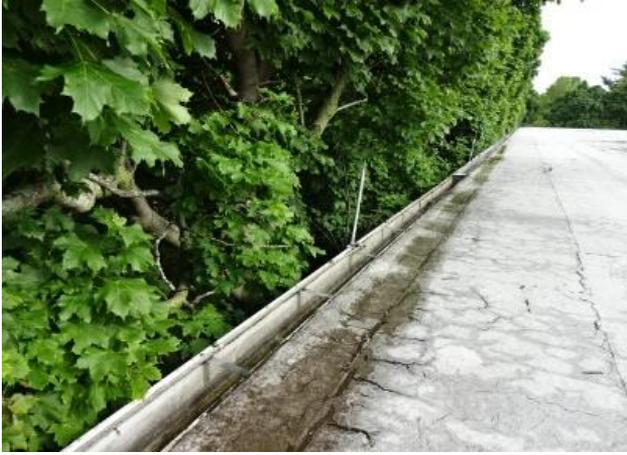
- The sloped roof over the Ice Arena is a built up system, and is in poor condition. There are reports of current leaking. Signs of past leaking were observed during the physical
- The flat roof area is a built up system that and is in fair condition. There are no reports of current leaking. Signs of past leaking were observed during the physical
- Access to the roof was gained by access door that is in good condition.
- There were no significant observations of standing water on the roof. Metal coping and
- The roof over the Pool Building is an asphalt shingle system that was installed in 1994, and is in fair condition. There are no reports of current leaking. Roof storm drainage is addressed through a system of gutters and downspouts, which are properly located, and in fair condition. No problems requiring attention were encountered with any roof penetrations.

Ice Arena Roof

- The roof over the Ice Arena requires replacement due to condition and age of system and projected lifecycle, with work recommended within 2-4 years. The flat roof over the rest of the building requires replacement due to condition, with work recommended within 4-7 years. The flashing and coping on the overall facility require replacement due to condition, with work recommended to be performed with roof replacements.
- Downspouts on the Ice Arena that are broken or missing sections require repairs as soon as possible.
- Add overflow drain or scuppers to the flat roof, with work recommended to be performed with roof replacements.
- The roof over the Pool Building requires replacement due to age of system and projected lifecycle, with work recommended within 2-4 years.
- Replace one broken downspout at the Pool Building, with work recommended as soon as possible.

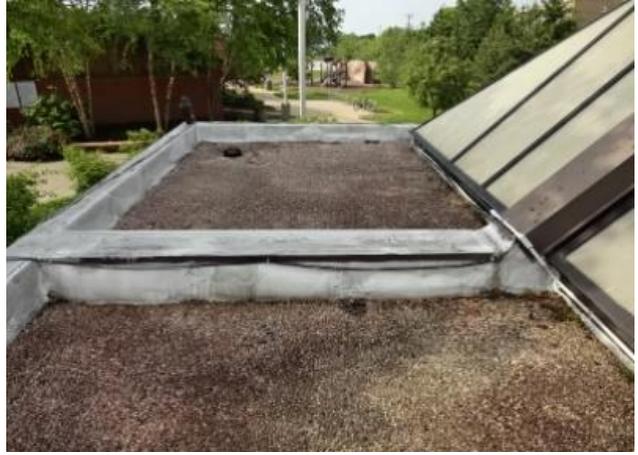
Flat Roof at Ice Arena Entrance

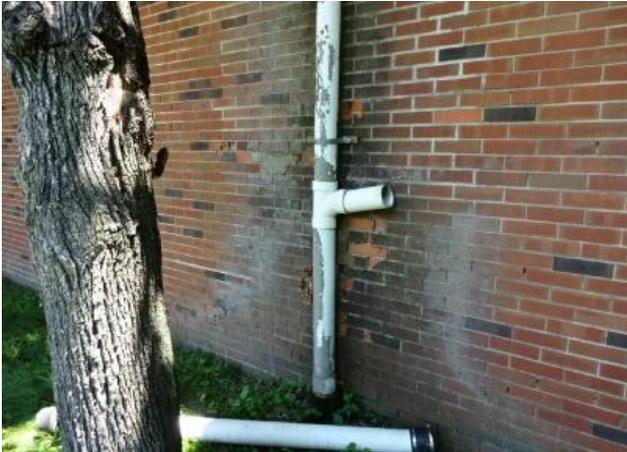
Broken Downspout at Ice Arena

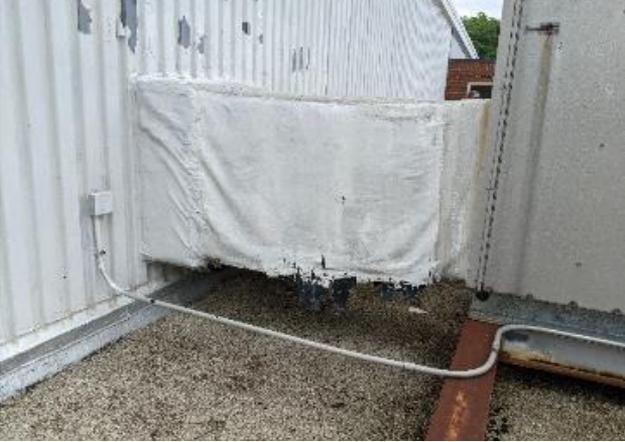
Deteriorating Duct Insulation at Munters Unit

- Provide ventilation where it is lacking in both buildings.
- Provide ventilation at the Snack Bar.
- Replace the Munters unit and insulation.

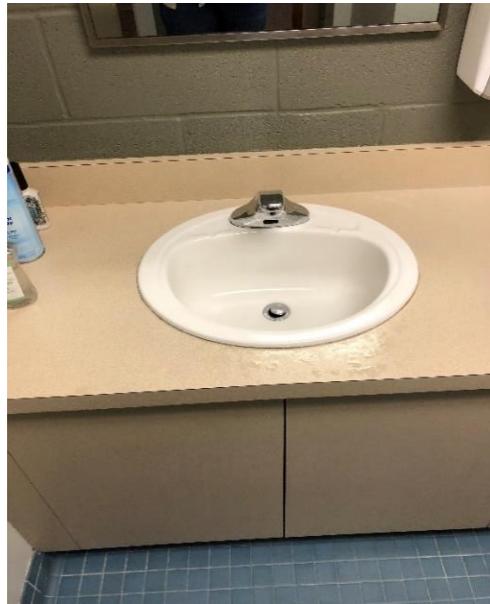
Non-ADA Lavatory in Staff Men's Restroom

- Continue replacement of manual fixtures to electronic style in both buildings.
- Replace EWCs that are not ADA and are not equipped with bottle fillers.
- Refer to Item J. General Finishes for kitchen equipment recommendations.

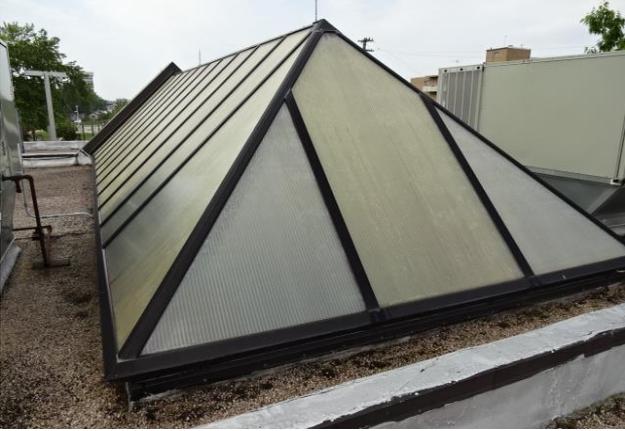
- The Ice Arena does contain 2 aluminum framed skylights with insulated polycarbonate glazing in fair condition. The building does not contain clerestories. Interior glass is not OBC-compliant.

Polycarbonate Skylight

Item	Cost	Unit	Whole Building	Sum	Comments
Skylight Panels	\$138.00	SQ. FT.	760.00	\$104,880.00	
Ice Arena Sum:				\$104,880.00

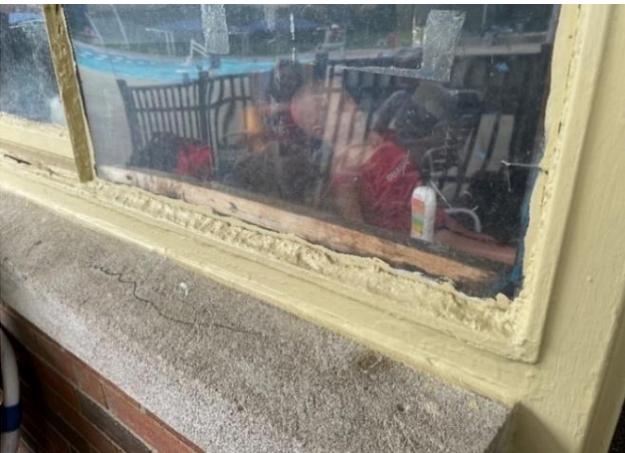
- The exterior doors in the Pool Building are equipped with hollow metal frame sidelights with single pane glazing. The sidelights are operable, without insect screens. Hollow metal frames are in good condition. Glazing kit frames are in poor condition.

Pool Building Window

- Replace Ice Arena exterior storefront doors, frames and transoms with thermally broken storefront framing and insulated glazing, with work recommended to be performed within 4-7 years. Replacement cost addressed in Item S. Exterior Doors replacement
- Replace polycarbonate skylight panels, with work recommended to be performed within 4-7 years.
- Replace the Pool Building window kits in the existing hollow metal frames, with work recommended within 2-4 years.

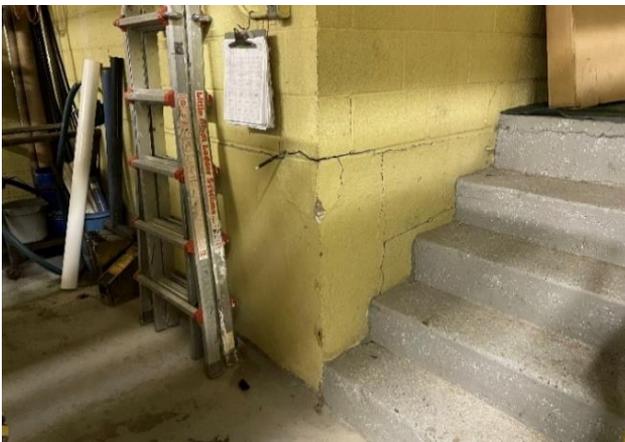
- The Ice Arena is equipped with concrete foundation walls on concrete footings, which displayed minor wall cracking in the mechanical room. The rest of the facility is in good condition. No grading or site drainage deficiencies were noted around the perimeter of the structure that are contributing or could contribute to foundation / wall structural deterioration.
- The Pool Building is equipped with concrete foundation walls on concrete footings, which displayed no locations of significant differential settlement, cracking, or leaking, and are in good condition. No significant issues related to foundation cracking or spalling were encountered. No grading or site drainage deficiencies were noted around the perimeter of the structure that are contributing or could contribute to foundation wall structural deterioration.

Ice Rink Foundation Cracking

- Repair areas of cracking in the Ice Arena Mechanical Room, with work recommended within 0-2 years.
- The Pool Building existing conditions require no renovation or replacement at the present time.

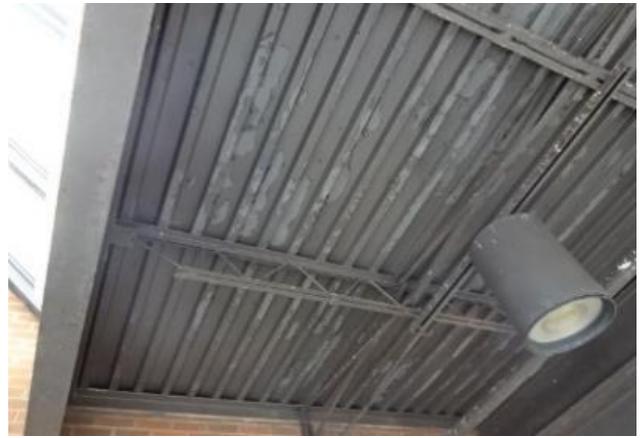
Soffit at Entrance

- Repaint entrance canopy metal wall panels, structural steel and metal deck, with work recommended within 0 -2 years.
- Provide tuckpointing at the Pool Building in all areas of mortar deterioration on brick screen walls and minor cracks on main building.

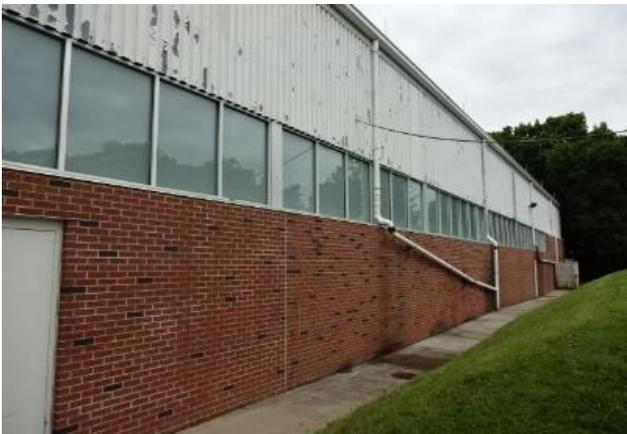
- The Ice Arena rink was constructed with a metal building system. The infill between the columns is 13' tall brick veneer on concrete masonry units, with metal wall panels from top of brick to the roof. Overall the brick is in good condition. Brick spalling and deterioration has occurred behind broken downspouts. Metal wall panels are in fair condition with peeling paint. Cracking of CMU has occurred in the Mechanical Room, Locker Room, and the Skate Rental area.

Metal Wall Panels

- Repaint Ice Arena metal wall panels, with work recommended within 0 -2 years.
- Replace masonry lintel at paired door at NW corner of Ice Arena, with work recommended within 0 -2 years.

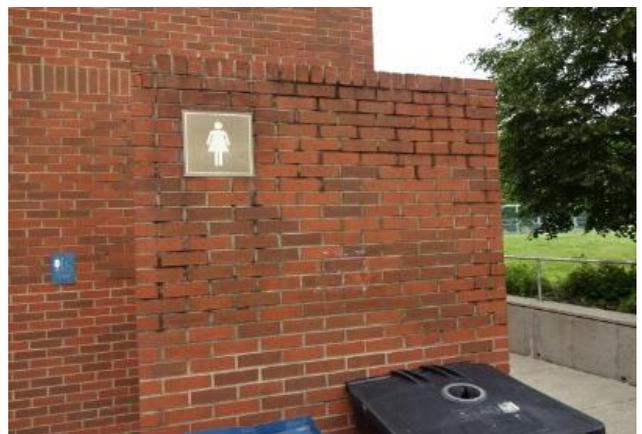
- The rest of the Ice Arena facility has a brick veneer on load bearing masonry wall system which displayed limited of deterioration, and is in good condition. Brick walls that screen the doors to the Men's and Women's Restrooms are capped with a row of brick. Water is penetrating the top of the wall can causing brick spalling and mortar deterioration.

Brick Screen Wall

- Tuckpoint brick at screen walls to restrooms and behind broken downspouts, NW corner of ice rink and chimney cap, with work recommended within 0 -2 years.

- Replace spalled brick at screen walls to restrooms and at broken downspouts, with work recommended within 0 -2 years.
- Prep and paint exposed steel lintels through the overall facility with painting of exterior doors and frames. Cost included with exterior door painting in Item S.

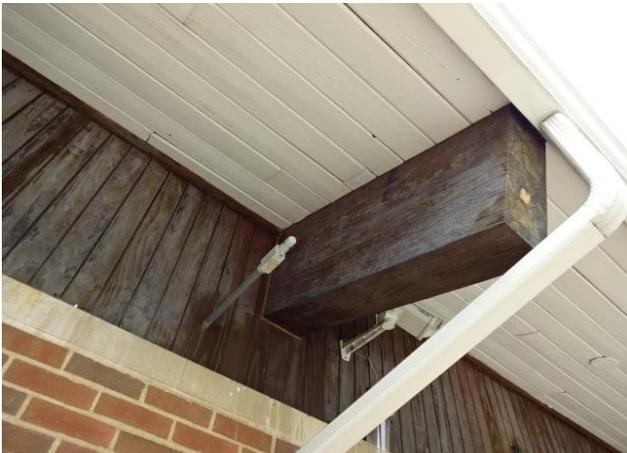
- The window sills are stone, and are in good condition. The exterior lintels are steel, and are in good condition. The chimneys are in good condition. Exterior soffits are of tongue and groove wood plank type construction, and in fair to poor condition. Fascia boards are wood and in mostly good condition.

Wood Soffits and Glulam Beams

- Replace damaged tongue and groove soffit and fascia board
- Paint steel lintels at screen walls.
- Paint soffits.
- Stain wood siding and exposed laminated beams.

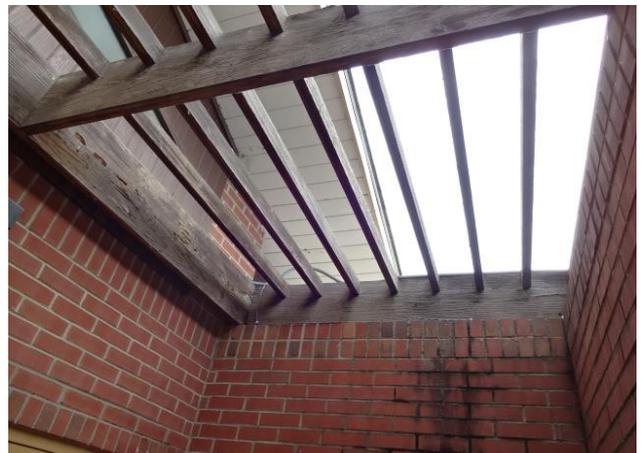
- The redwood trellis at the doors to the Restrooms is in poor condition.

Redwood Trellis

- Replace redwood trellis.

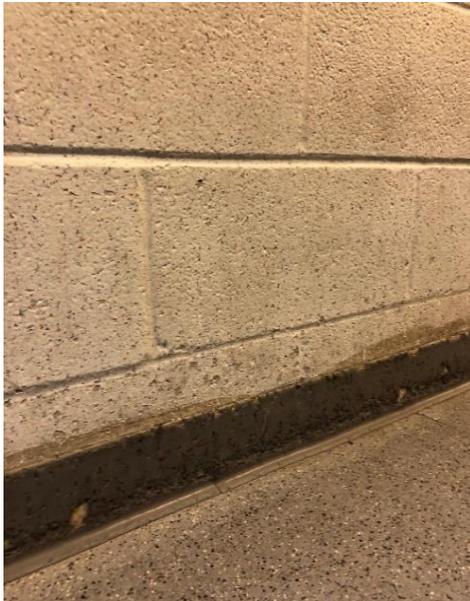
First Floor Corridor Wall, Base, and Floor Condition

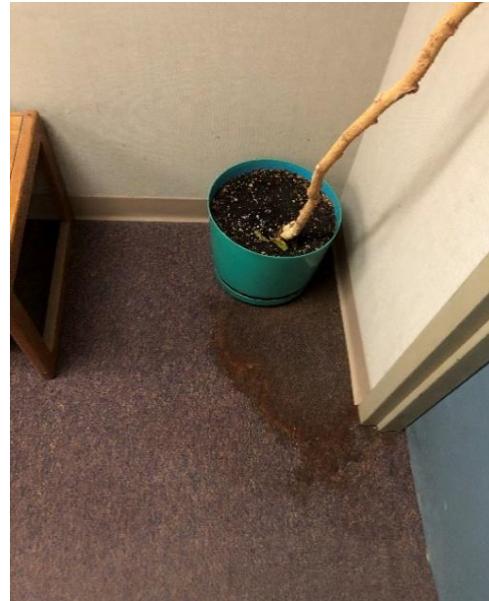
Damaged Second Floor Carpet

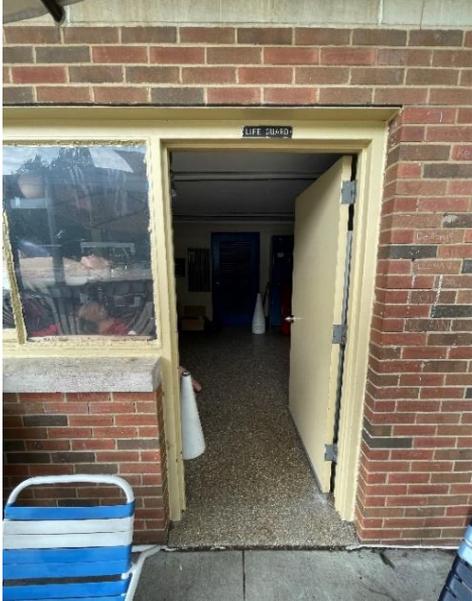
Lifeguard Door with Knob Hardware

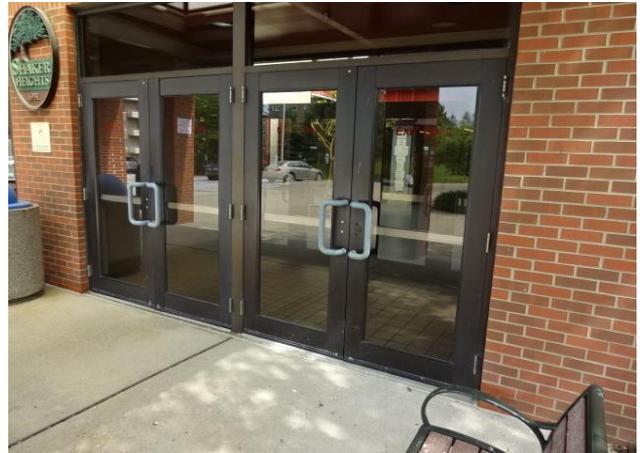
Main Entrance Requiring ADA Operators

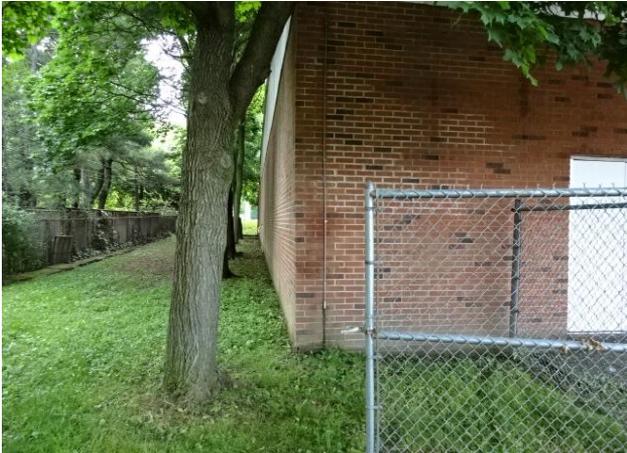
Trees Growing Close to Ice Arena

Item	Cost	Unit	Whole Building	Sum	Comments
Concrete Curb Replacement	\$40.00	LINEAL FT.	100.00	\$4,000.00	
Paint Wood Fence	\$1.25	SQ. FT.	1400.00	\$1,750.00	
Remove 12" Caliper Trees	\$3,500.00	EACH	16.00	\$56,000.00	
Concrete Slab at Egress Door	\$1,200.00	LUMP SUM	1.00	\$1,200.00	
2" Caliper Trees	\$700.00	EACH	16.00	\$11,200.00	
Ice Arena Sum:				\$74,150.00

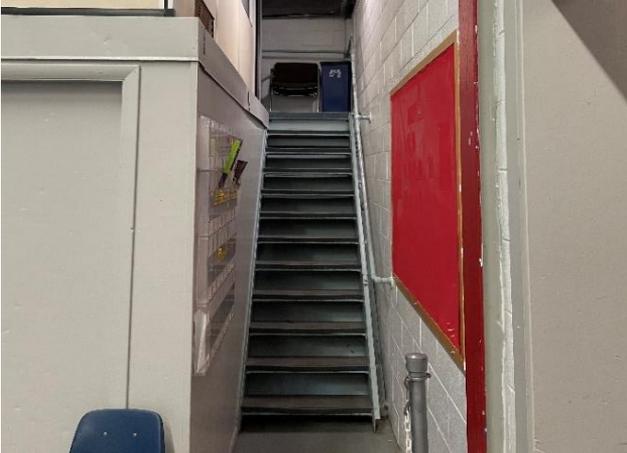
Handrail to be Replaced

Item	Cost	Unit	Whole Building	Sum	Comments
New Handrail	\$5,000.00	LEVEL	1.00	\$5,000.00	
Ice Arena Sum:				\$5,000.00
