Re: Ground Penetrating Radar Survey Report – Warrensville West Cemetery, Shaker Heights, Ohio

The Mannik & Smith Group, Inc. (MSG) was retained by the City of Shaker Heights to perform a Ground Penetrating Radar (GPR) investigation for the Warrensville West Cemetery located in Shaker Heights, Ohio (Site). This project is part of the Historic Preservation Master Plan project for the Warrensville West Cemetery.

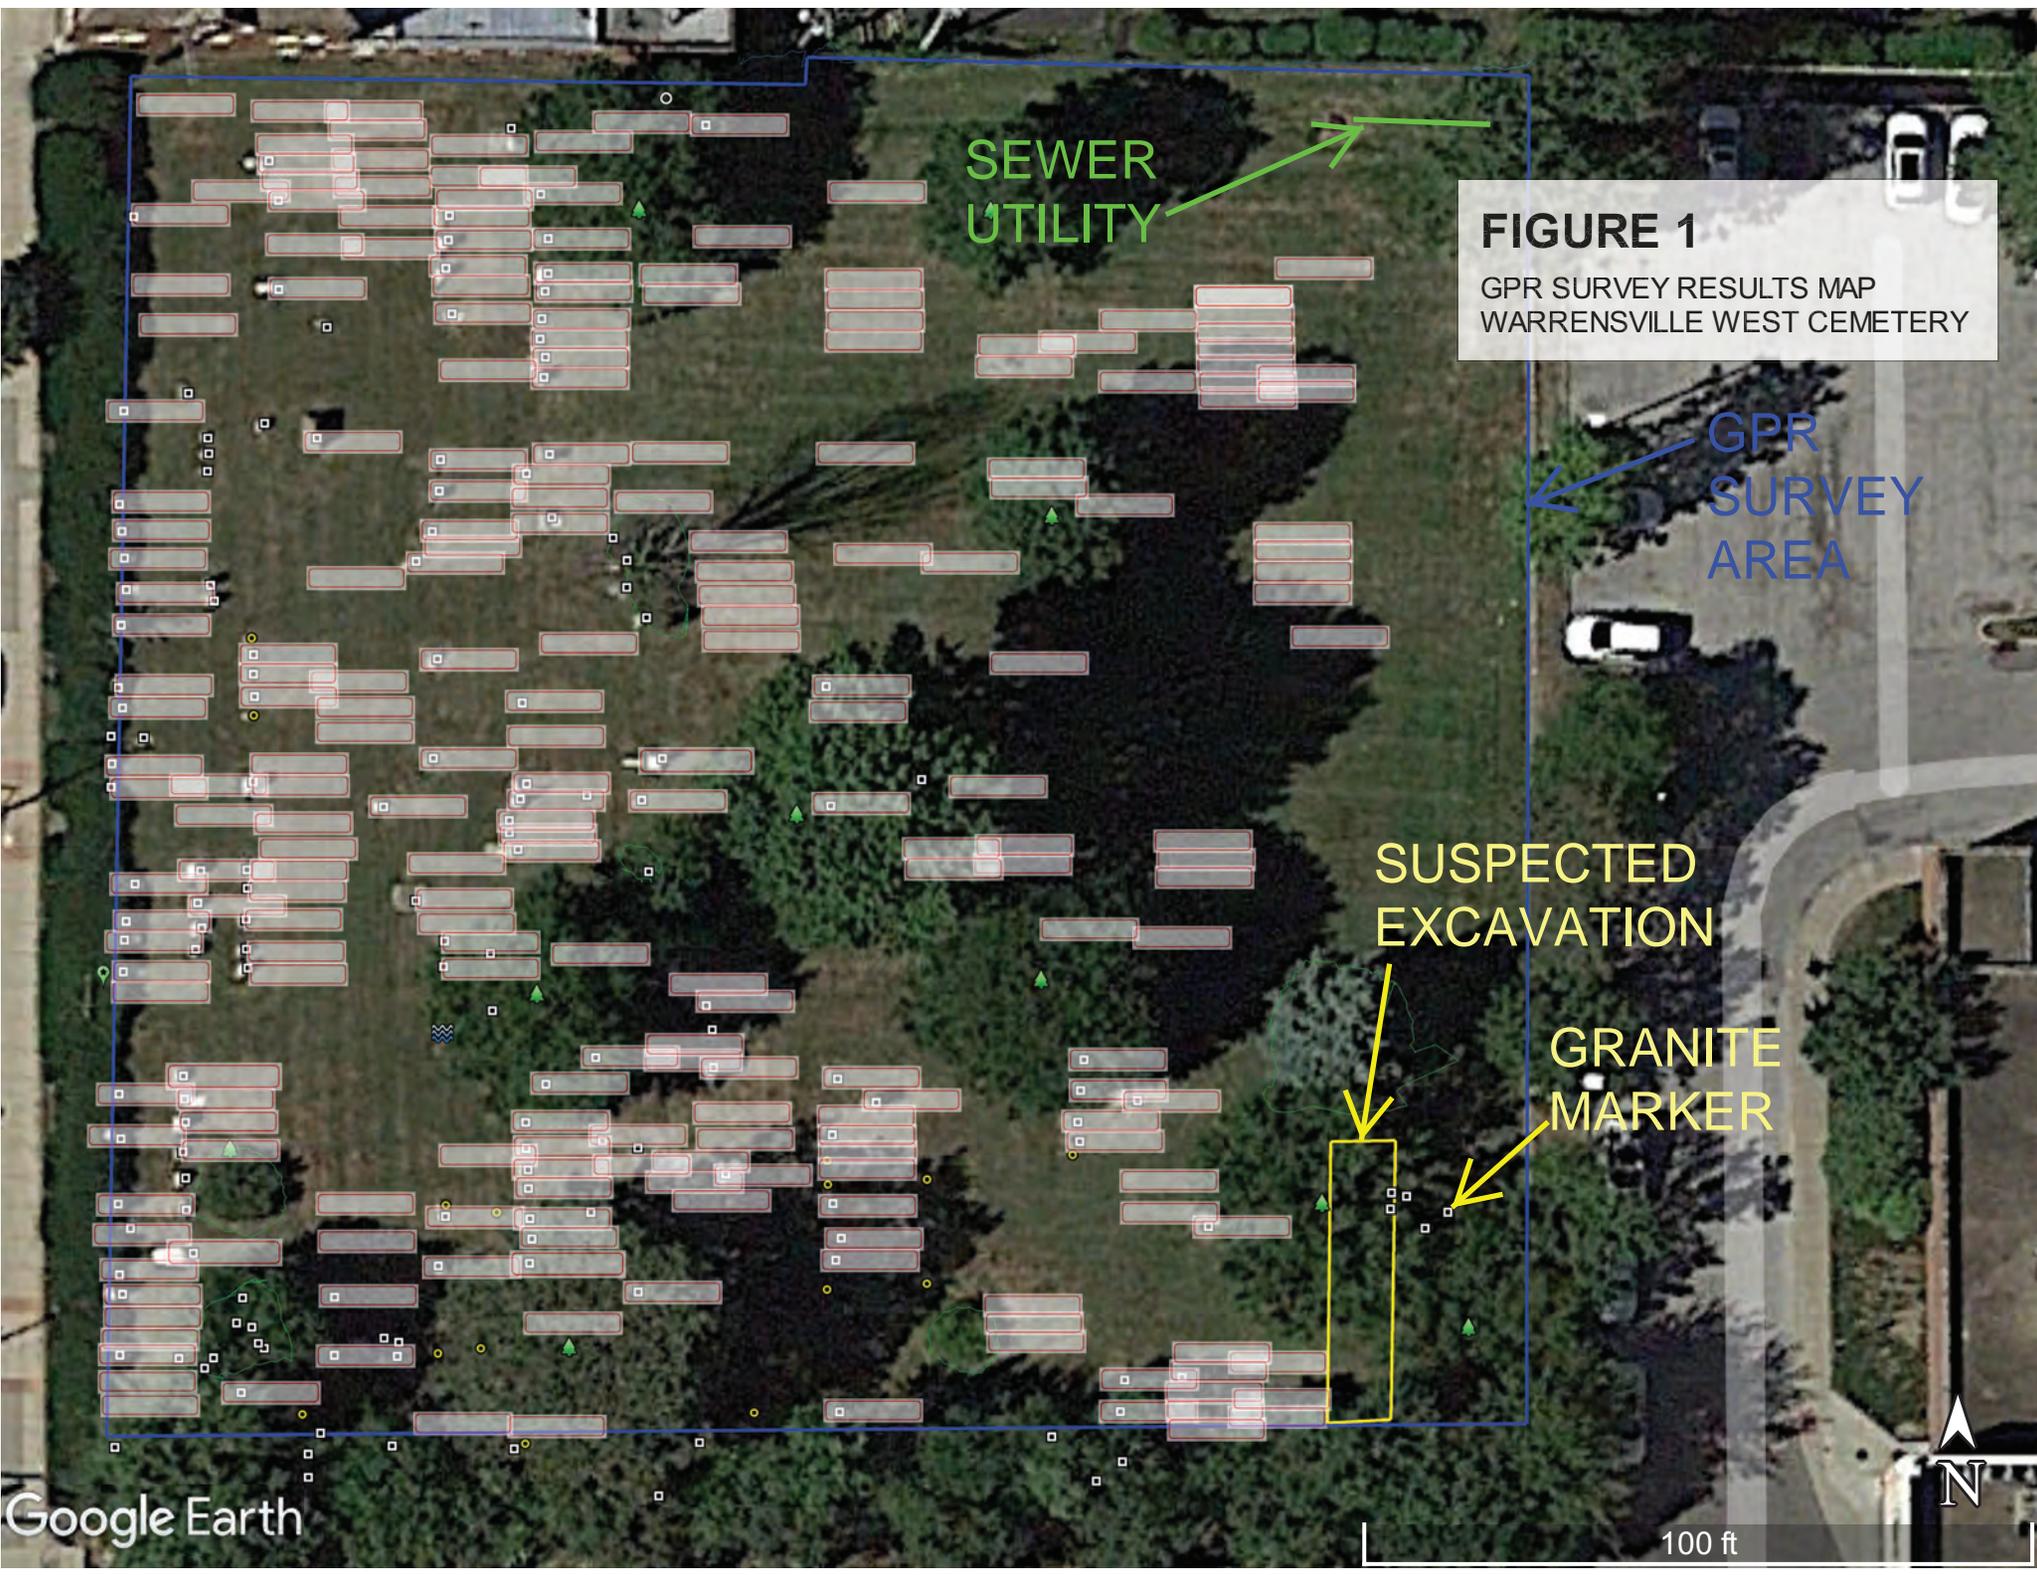
FIGURE 1

GPR SURVEY RESULTS MAP
WARRENSVILLE WEST CEMETERY

SEWER
UTILITY

GPR
SURVEY
AREA

SUSPECTED
EXCAVATION

GRANITE
MARKER

Based on the GPR survey data, all significant detected anomalies, including burials located at the Warrensville West Cemetery, are depicted on *Figure 1, GPR Survey Results Map*. Photos of field activities are located in Figure 2 through Figure 4. Multiple select examples of noise and anomalies detected during the GPR survey at the Warrensville West Cemetery are depicted in Figure 5 through Figure 15, including:

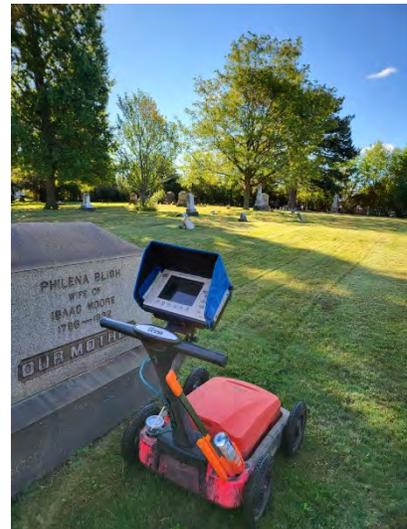
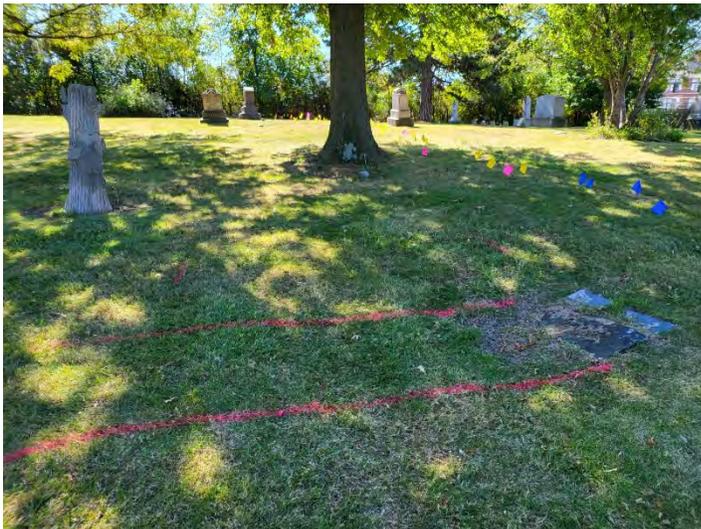
Figure 4 (left): View of burial marker and GPR anomaly field marking of suspected burial (marked in pink) at the Warrensville West Cemetery, facing south.

3. Figure 7 illustrates the hyperbolic response of a linear anomaly indicative of a subsurface utility located in the northeast portion of the cemetery leading to the east towards the east cemetery boundary as indicated on *Figure 1*. A GPR radiogram from a profile collected across the linear GPR anomaly indicative of the suspected utility is illustrated in *Figure 4* below.

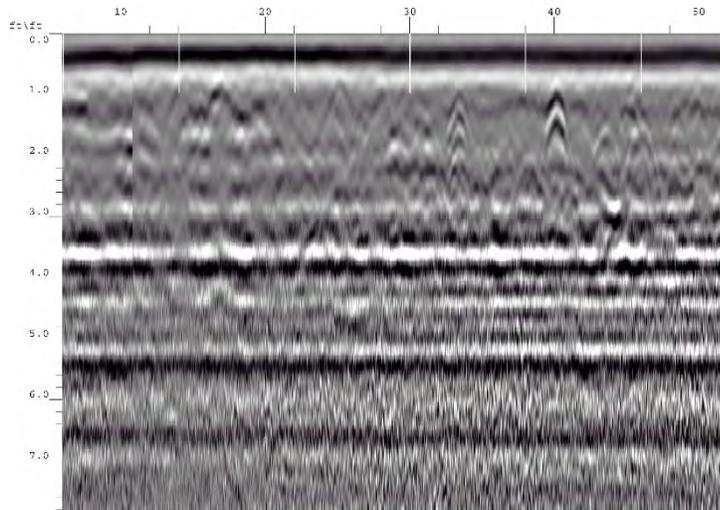
Figure 5 (left): GPR radiogram illustrating the representative signature of the clayey till soils and soil layers present across the Warrensville West Cemetery.

1. Figure 5 illustrates an example of a typical GPR radiogram collected during the GPR survey at the Site, which is representative of the clayey till soils and soil layers present across the Site.

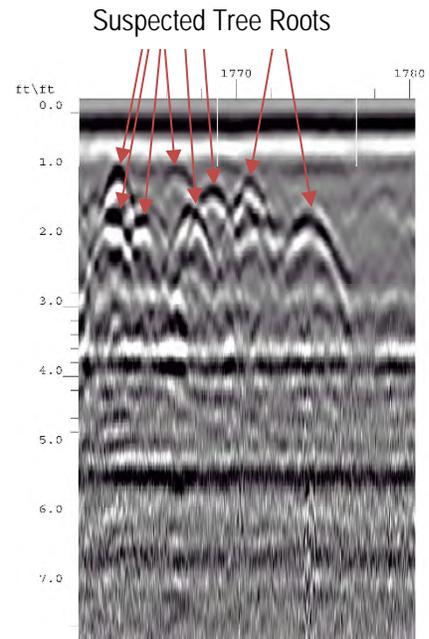
Figure 6 (right): GPR radiogram illustrating the hyperbolic response of multiple linear anomalies indicative of suspected tree roots encountered at the Warrensville west Cemetery..

2. Figure 6 illustrates multiple linear anomalies detected indicative of suspected tree roots and are an example of one of the sources of noise detected at the Site.

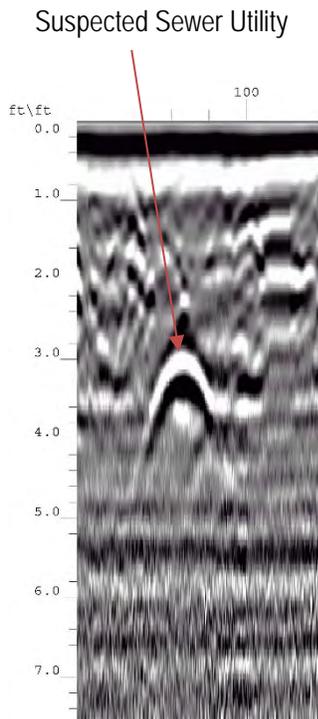
Figure 7 (left): GPR radiogram illustrating the hyperbolic response of a linear anomaly indicative of a subsurface utility that was detected from the sewer catch basin located in the northeast portion of the cemetery leading to the east towards the east cemetery boundary.

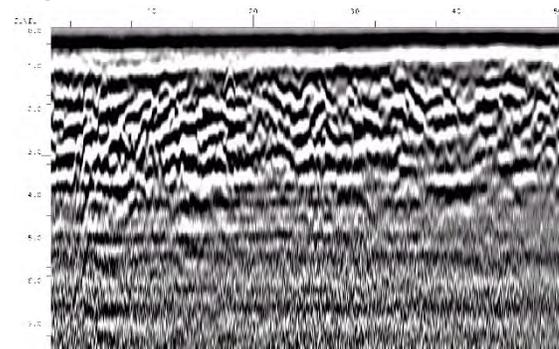
Figure 8 (below): GPR radiogram of suspected fill material from previous excavation activities at the Site located along the east retaining wall and north drainage area within the cemetery. While fill material can be a source of interference to detection of burials during a GPR survey, only a small portion of the cemetery appears to contain fill material that interferes with burial detection.

4. Figure 8 illustrates a GPR radiogram of typical noise encountered of suspected fill material from previous excavation activities at the Site, not directly related to burials. Noise from fill material was encountered along the east cemetery retaining wall and north drainage area within the cemetery.

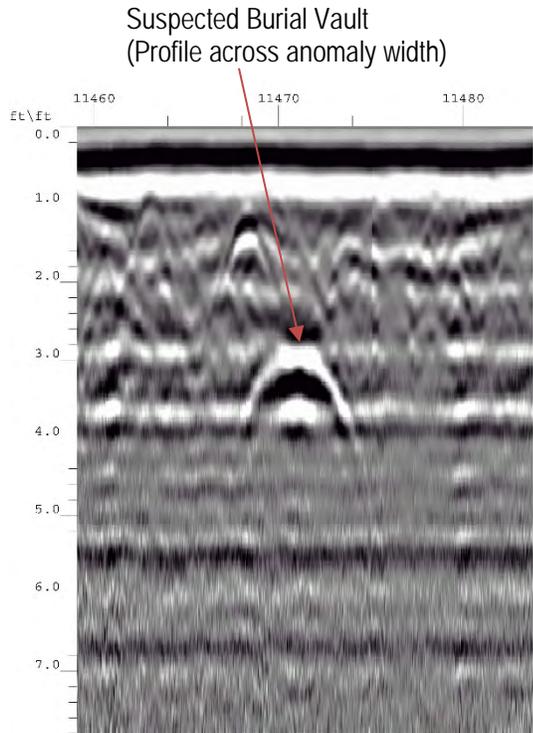
Figure 9 (left): GPR radiogram of a linear anomaly indicative of a suspected burial vault located within the Warrensville West Cemetery. Note how the wider hyperbolic response of a suspected burial vault (across the width of the vault) is different than that of the hyperbolic response of a cylindrical utility structure in Figure 7.

5. Figure 9 illustrates a GPR radiogram of a linear anomaly indicative of a suspected burial vault located within the Warrensville West Cemetery. The wider hyperbolic response of a suspected burial vault illustrated in Figure 9 is different than that of the hyperbolic response of a cylindrical utility structure illustrated in Figure 7.

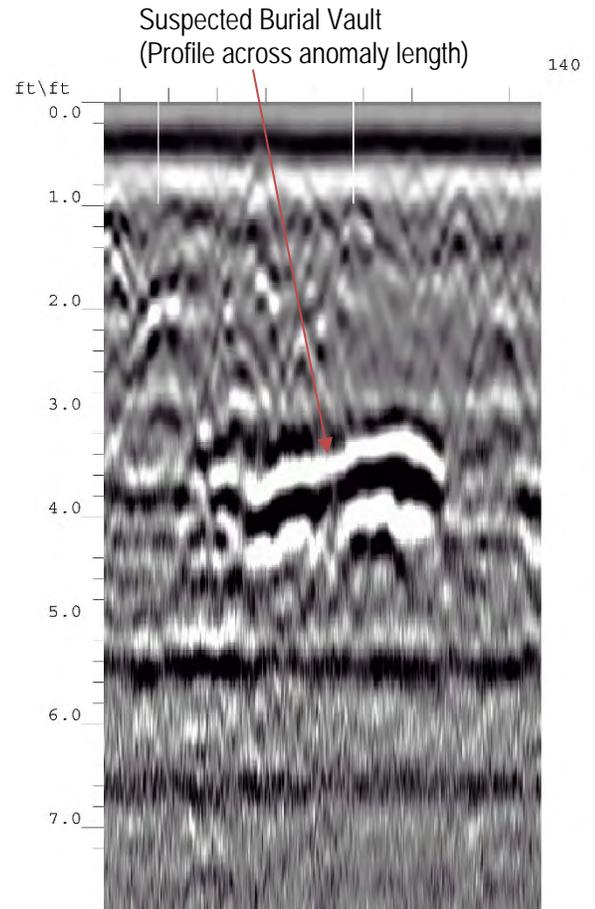
Figure 10 (right): GPR radiogram of a linear anomaly indicative of a suspected burial vault located within the Warrensville West Cemetery. Note how the longer “flat topped” response of a suspected burial vault (across the length of the vault) is different than that of the hyperbolic response across the width of a burial in Figure 9.

6. Figure 10 illustrates a GPR radiogram of a linear anomaly indicative of a suspected burial vault located within the Warrensville West Cemetery. Note how the longer "flat topped" response of a suspected burial vault across the length of the vault is different than that of the hyperbolic response across the width of a burial illustrated in Figure 9.

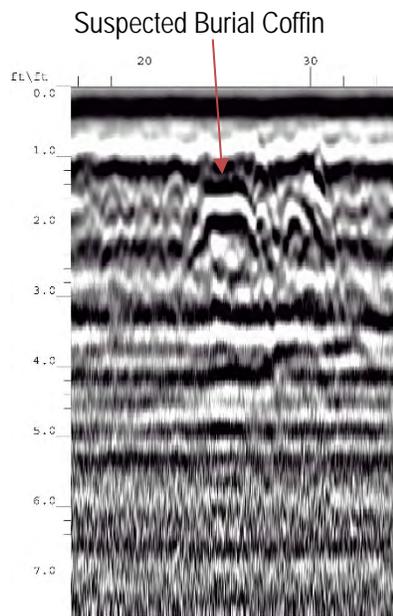
Figure 11 (left): GPR radiogram of a linear “flat topped” anomaly indicative of a suspected burial coffin located within the Warrensville West Cemetery. This burial is characteristic of multiple other burials detected within the northeastern portion of Warrensville West Cemetery, which were without burial markers or monuments.

7. Figure 11 illustrates a GPR radiogram of a linear "flat topped" anomaly indicative of a suspected burial coffin located within the Warrensville West Cemetery. This burial is characteristic of multiple other

burials detected within the northeastern portion of Warrensville West Cemetery, which were without burial markers or monuments.

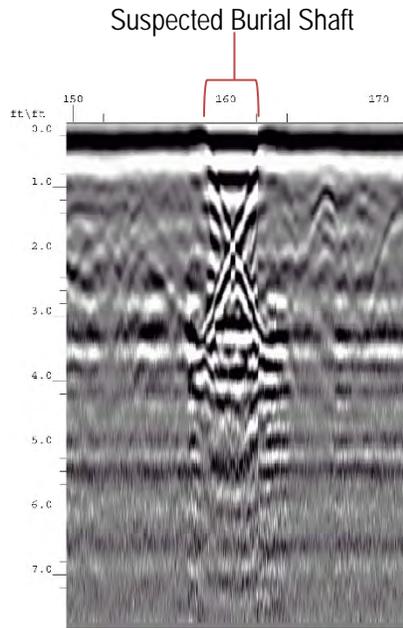
Figure 12 (left): GPR radiogram of a linear anomaly indicative of a burial shaft located within the Warrensville West Cemetery.

8. Figure 12 illustrates a GPR radiogram of a linear anomaly indicative of a burial shaft located within the Warrensville West Cemetery.
9. Figure 13 illustrates a GPR radiogram of multiple linear anomalies indicative of burials located within the Warrensville West Cemetery. These particular burials had markers or monuments located adjacent at the surface.

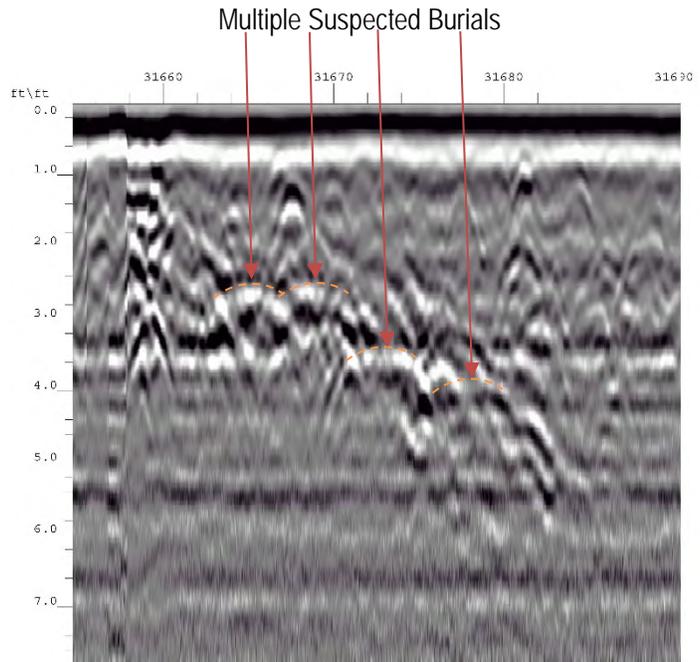
Figure 13 (right): GPR radiogram of multiple linear anomalies indicative of burials located within the Warrensville West Cemetery. These particular burials had burial markers or monuments located adjacent at the surface.

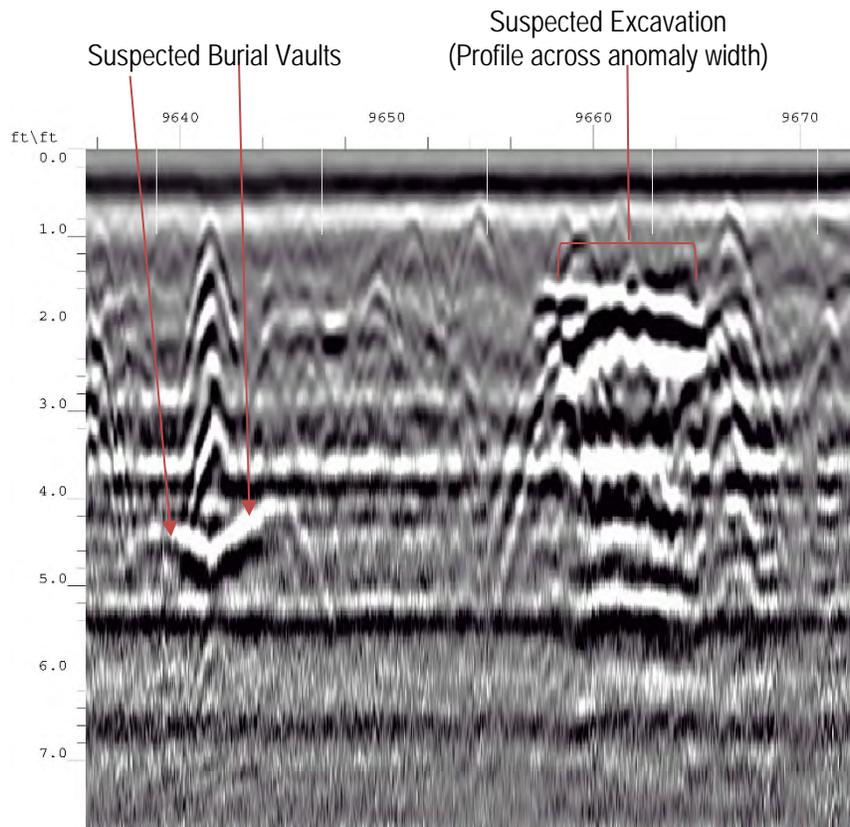
Figure 14 (left): GPR radiogram of two linear anomalies indicative of suspected burial vaults and an anomaly indicative of a suspected excavation. This excavation lies adjacent to the granite marker and memorial plaque indicating the final resting place of the Shakers of the North Union Society located within the Warrensville West Cemetery.

10. Figure 14 illustrates a GPR radiogram of two linear anomalies detected indicative of suspected burial vaults and an anomaly indicative of a suspected excavation. This excavation lies adjacent to the granite marker and memorial plaque indicating the final resting place of the Shakers of the North Union Society located within the Warrensville West Cemetery.

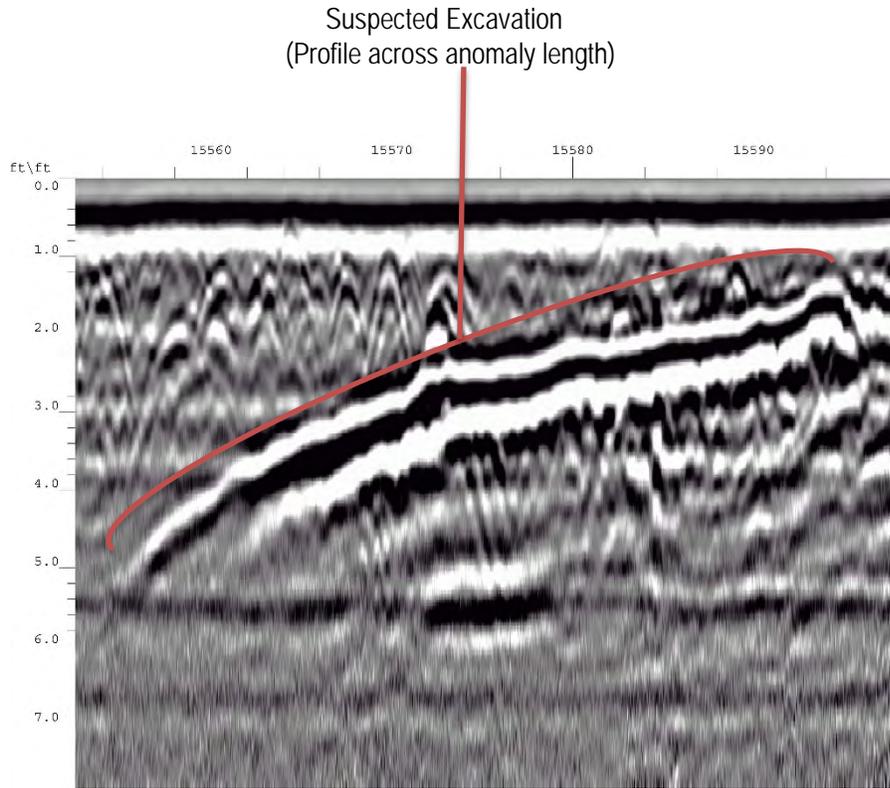
Figure 15 (left): GPR radiogram of an anomaly indicative of a suspected excavation, which is sloped from approximately one to five feet below ground surface. This excavation lies adjacent to the granite marker and memorial plaque indicating the final resting place of the Shakers of the North Union Society located within the Warrensville West Cemetery.

11. Figure 15 illustrates a GPR radiogram of an anomaly indicative of a suspected excavation, which is sloped from approximately one to five feet below ground surface. This excavation lies adjacent to the granite marker and memorial plaque indicating the final resting place of the Shakers of the North Union Society located within the Warrensville West Cemetery.
